approach

NAVAER 00-75-510

MAY 1960

The Naval Aviation Safety Review

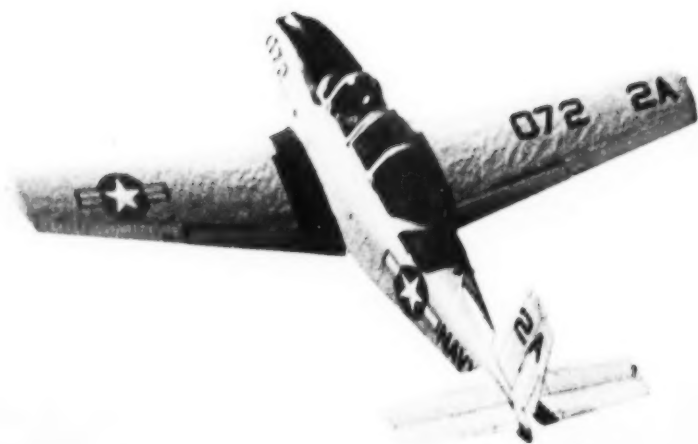
This one-in-a-million photo clearly illustrates compression wrinkles as they occur on the upper surface of aircraft airfoils during high positive G maneuvers. The picture is highly unusual in that a combination of several factors was necessary: a high G pull-up, light rays striking the upper surface of the wing at a low angle, and, of course, the shutter of the camera open at the exact second the first two conditions were satisfied. The aircraft shown is not exclusively susceptible to this phenomenon.

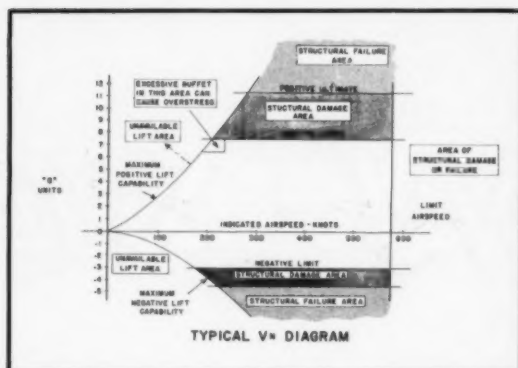
Figure 1

Vn Diagram

The basic source of pilot information concerning the maneuvering forces allowable in any particular aircraft is the Vn diagram (see figure 1). The basic Vn diagram usually indicates the symmetrical forces allowable under certain weight, altitude and speed conditions. Variations or interpolations of this diagram are necessary if conditions other than those established for the basic Vn diagram exist, i.e. changes in weight, altitude, weight distribution, . . . Each change in configuration must be considered and the allowable acceleration should be computed prior to undertaking any flight which will include high G maneuvers.

If the stall and buffeting take place near the maximum allowable G-limit or if buffeting is allowed to become severe, it can cause structural damage to the aircraft. If the aircraft is flown to the buffet but not into it, within the allowable G-limits, no damage will occur (see figure 1).

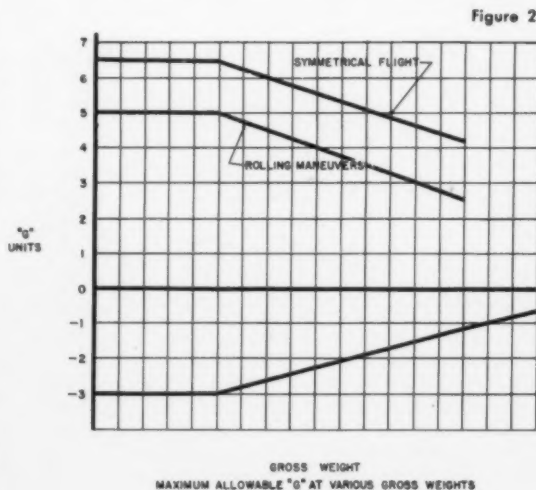
The basic Vn diagram is established for a certain gross weight of the aircraft. If the gross weight is in excess of that stipulated for the basic Vn diagram, the forces on the aircraft will actually exceed structural limits. The lift to support the excess weight is greater than normally would be needed and the forces on the wing structure are above allowable limits. Figure 2 shows the relationship between weight and G allowable for a standard fighter.

To avoid exceeding the limit load, the gross weight for any airplane configuration must be computed prior to the initiation of any high G-maneuver. As can be seen from figure 2, as the gross weight is increased the limiting G is lowered.

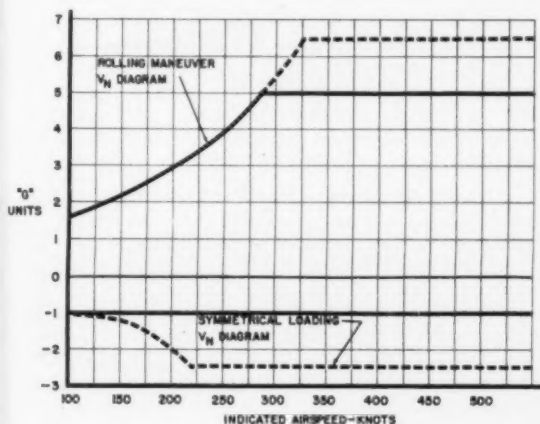
Figure 3

Rolling Maneuvers

If a rolling movement is induced during a high G-maneuver the distribution of the forces over the aircraft no longer remain equal. The torsional forces put on the wing by the application of the flight controls plus the uneven lift distribution may cause the forces on the wing to be greater than those for which it was designed. Usually the aircraft is designed to withstand only 80 percent limit load when the load is combined with a maximum roll rate maneuver (see figure 3). Therefore, for all practical purposes the basic Vn diagram is shrunk and is no longer applicable in its entirety under the above conditions.

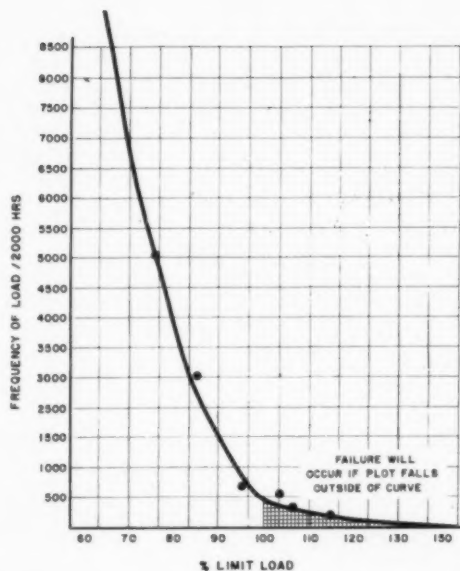
Aircraft structures are affected in the same manner. If the aircraft is loaded excessively, i.e., somewhere between the limit load and the ultimate failure point, a sufficient number of times, a failure will take place. The diagram in Figure 4 indicates what one standard fighter will take in the way of excessive loads. As can be seen, provisions have been made to cover what should be the normal G levels encountered. However, if excessive G is incurred too often the pilot falls outside the curve and a failure results.

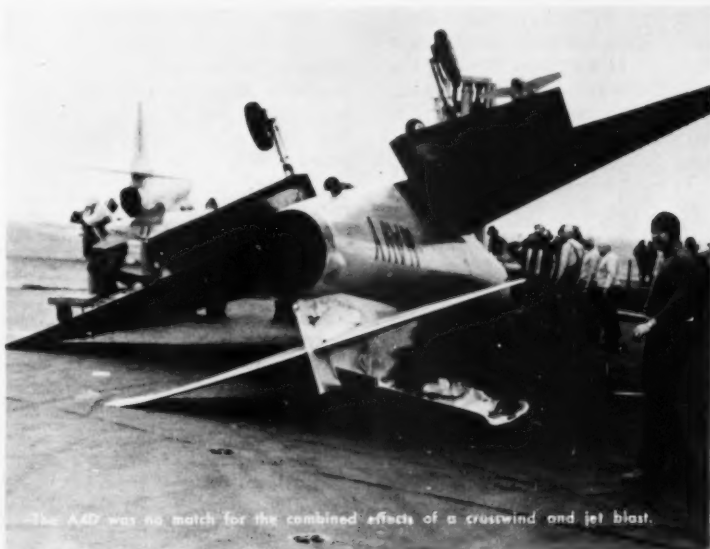
The A4D was no match for the combined effects of a crosswind and jet blast.

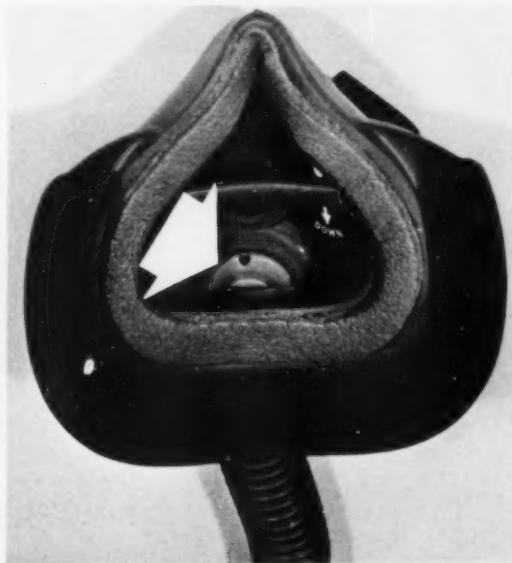
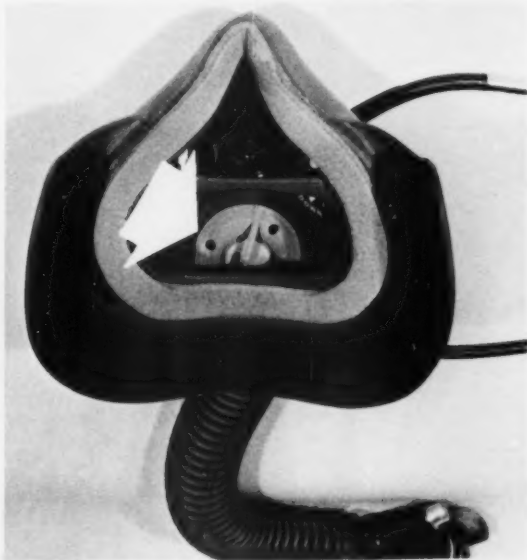
Only one of these masks is correct, and safe. Which one? Dr. Ewing discusses in this article the hazards that can befall you if your exhalation valve is unseated like the one on the left.

examined both by the pilot and the flight surgeon and no abnormalities were noted. That is, until the flight surgeon happened to hold the mask up to the light, quite by accident, and saw light coming through the exhaust port, past the exhalation valve. The exhalation valve was *completely unseated*, but neither the pilot nor the flight surgeon had noticed this on their examination of the mask. The mask, even with the exhalation valve completely unseated, *would still pass the functional tests in a manner satisfactory to most pilots*, unless distorted slightly by pulling "G" or by tightening the mask.

4. *If there is an accident in which hypoxia is a suspected factor, try to recover the oxygen mask and check the position of the exhalation valve. It may give you the answer.* ●

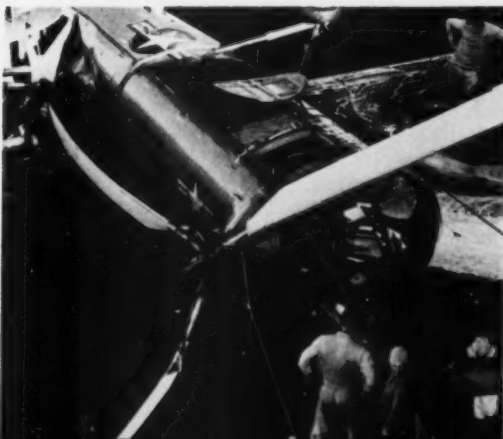
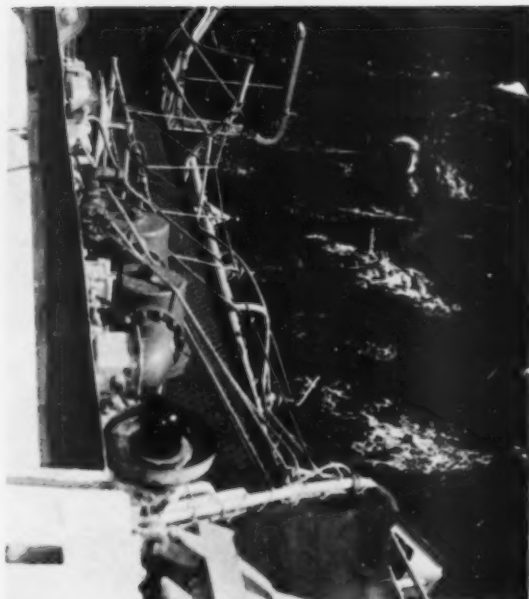
Mute evidence of an over-the-side loss of an F11F together with its plane captain—some 25 feet of catwalk guard rail went with the aircraft. Life belts were recommended for crewman manning unsecured aircraft.

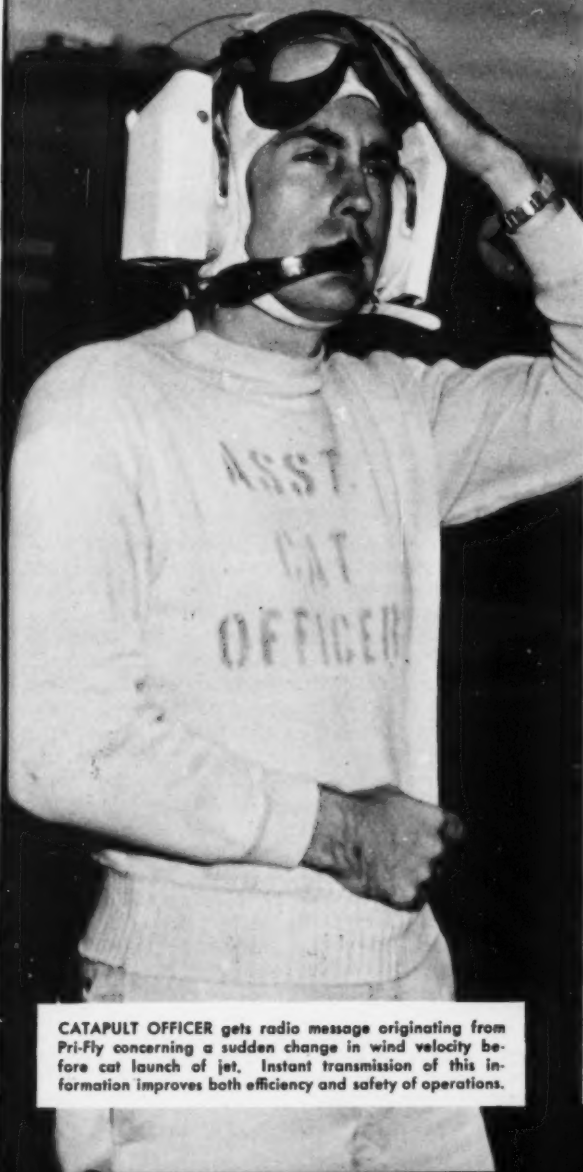
CATAPULT OFFICER gets radio message originating from Pri-Fly concerning a sudden change in wind velocity before cat launch of jet. Instant transmission of this information improves both efficiency and safety of operations.

AN approach to the problem of coordinating flight deck operations is this transistor radio helmet.

While this particular helmet is reported to cost about \$1000, the ability to communicate appears worth its cost in view of its contribution to flight deck efficiency and accident prevention. It is a modification of the Army AN/PRC-34 helmet radio. The compact receiver-transmitter is equipped with a boom-type, noise-filtering microphone and is battery operated.

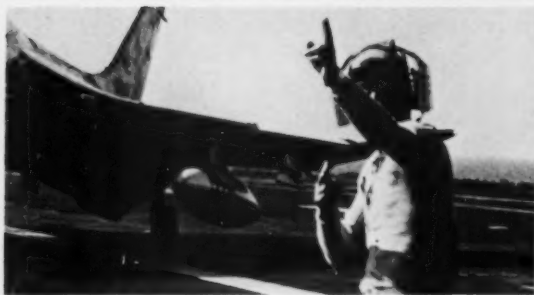
FLIGHT DECK CPO directs spotting of an F4D after receiving details from Flight Deck Officer stationed aft on FORRESTAL's more than 1000-foot flight deck.

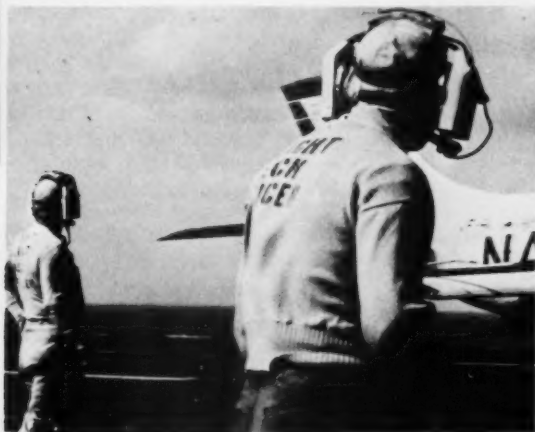
FLIGHT DECK OFFICER in foreground stands ready to relay pilot's readiness status after flight deck recovery of F3H. This enables flight deck people to make prompt disposition of the aircraft—
